The 2002 Core Banks Beach Wreck Survey

A Field Survey Conducted By SIDCO In Support Of The NCUAB Beach Wreck Program.

Beach Wrecks South (Cape Lookout to Drum Inlet)

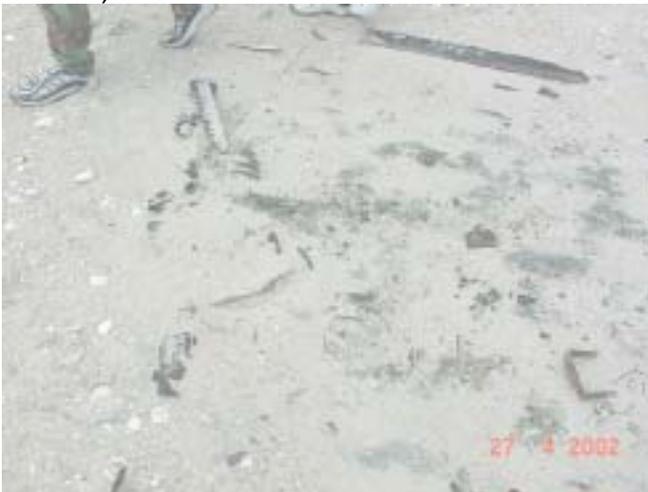
Charred wood and blackened iron fasteners are all that is left of this structure; fortunately it proved to be a fairly modern fishing camp and not an irreplaceable historic shipwreck structure. Sites like this are seen all up and down the North and South Core Banks area.

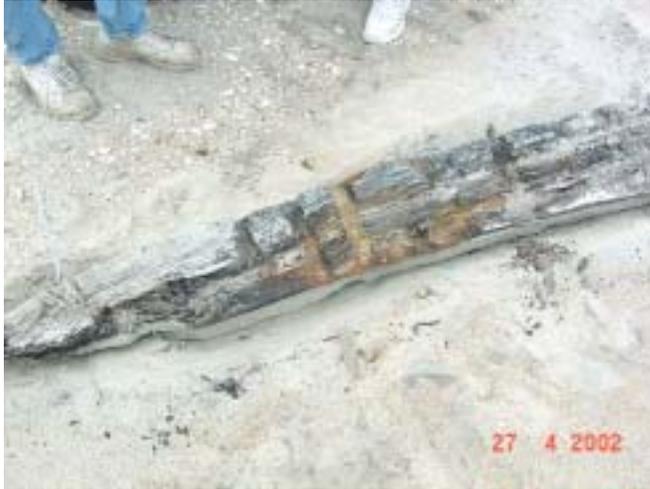
Single 001

This was a single timber lying by itself high in the dunes, well away from the high water mark. It was not tagged because it was a single piece and we had a

limited number of tags. The timber was located at **N 34 46'.550 W 76 23'.840**. It measured 8'4" long and had several wooden fasteners or "tre'nles". These were the only fasteners present on the structure. The fasteners patterns were one in the middle of the timber and two more at the lower edge. This pattern continued for the length of the piece.

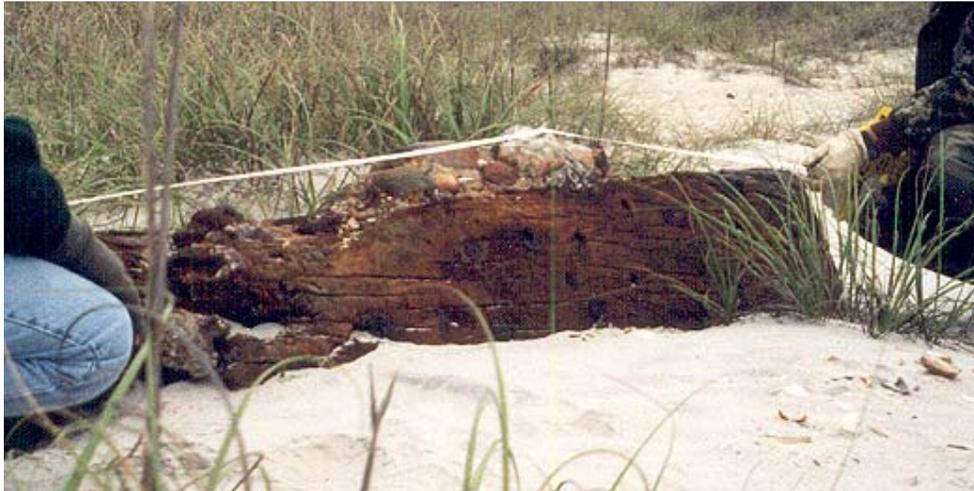
The intricate makeup of this structure was both beautiful and complex. A multiple media structure of wood and stone, with both iron and brass fasteners,

all concreted together by coral remains and iron oxide. Though it was a single timber, the lower side was covered by a

mixture of ballast stone, coral and other organic matter and iron oxide (chemical "left-overs" from rusting iron). There were iron fasteners passing through the timber from the bottom, or ballast stone side, and a single "copper" or brass fastener on the opposite side, probably from sheathing or sealing planking. The structure was not previously tagged and DCR tag number 00, 410 was attached.

The site was located at **N 34 45'.468 W 76 24'.758**. The fasteners were placed in a "5-4-3" pattern much like dots on a set of dominos. The timber measured 10'X 12" X15".

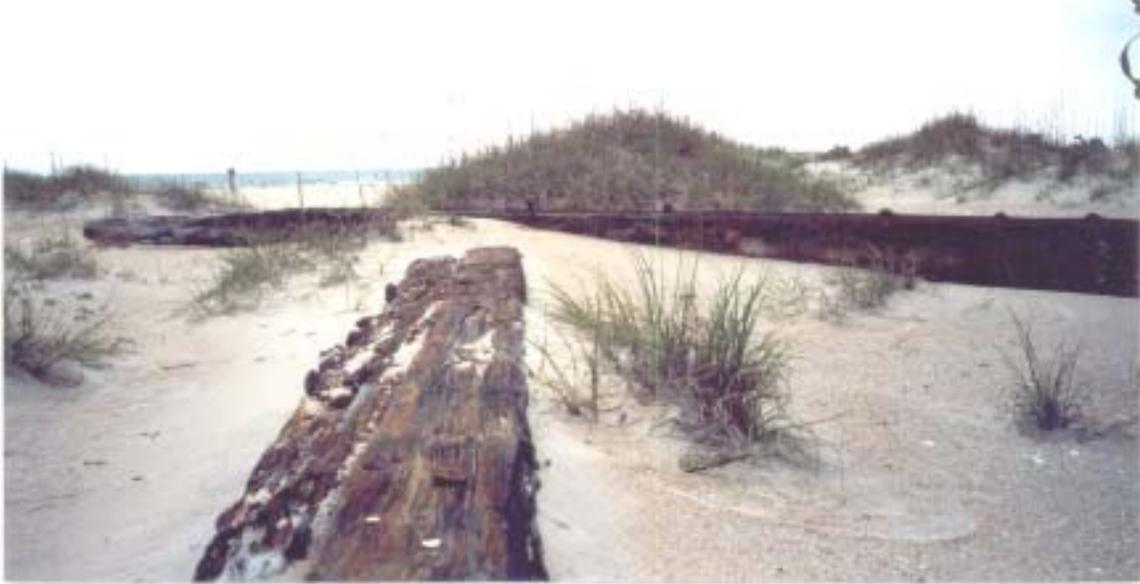
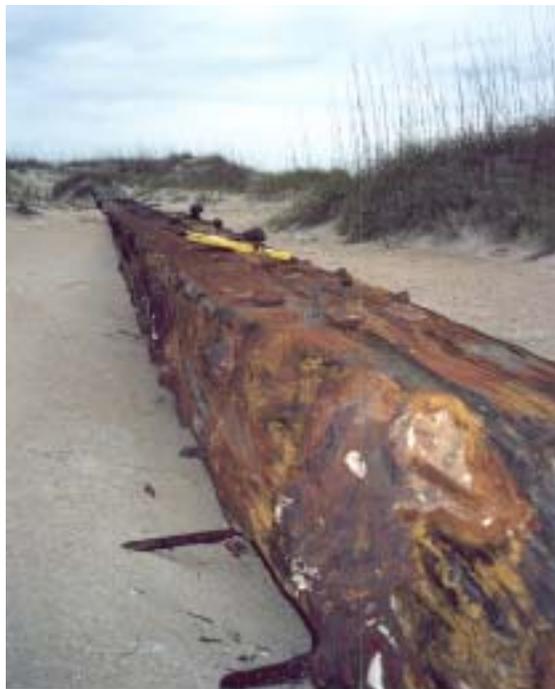
00, 411

Site 411 was a large amount of structure, spread over a 100'X 100' area. It was most probably the keel, keelson and framing timbers, or some combination of the lower hull structure parts, from a single vessel. It was nearly impossible to re-build the pieces into a site drawing, so a partial sketch was done and photographs were taken, in an attempt to at least record the debris.

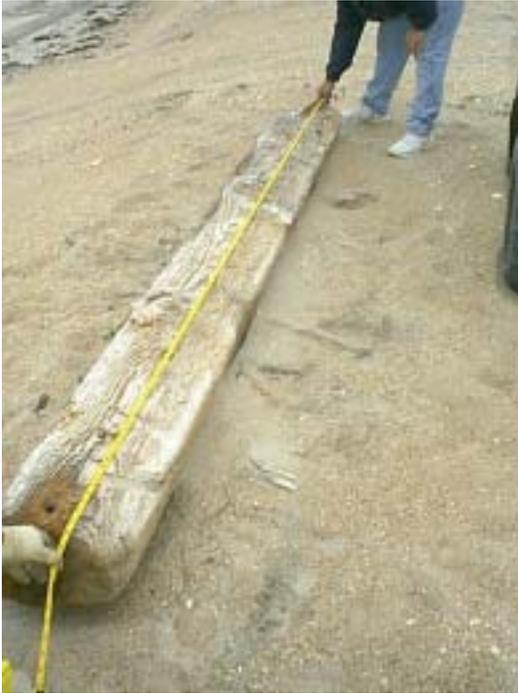
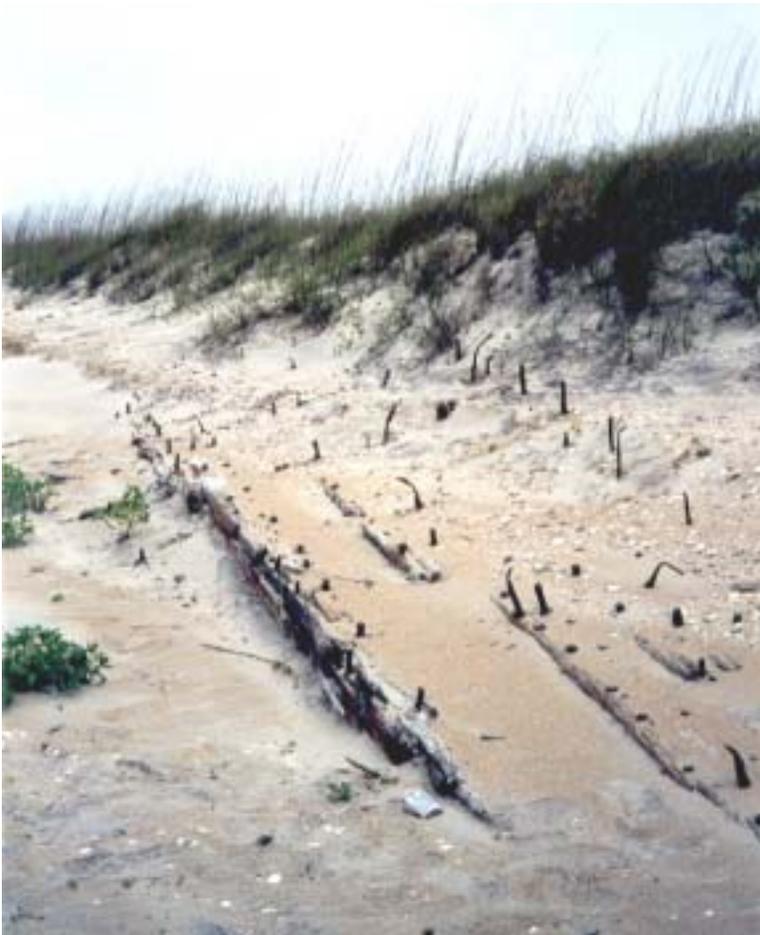
00, 412

The single timber we tagged 00, 412, still had a piece of old nylon rope still attached where a careless camper had attempted to drag it into their campfire. It was found lying near the high water mark, and in plain sight of passersby, at **N 34 42'.663 W 76 27'.276**. This timber had evidence of only a single iron fastener, and measured 12.5'X 1'2"X 1'. It is hoped by our team, that programs in the future will help dissuade vandalism like this.

SIDCO Team members take measurements on structure number 00, 412. This timber had a piece of rope still attached indicating an attempt to vandalize this historic artifact.

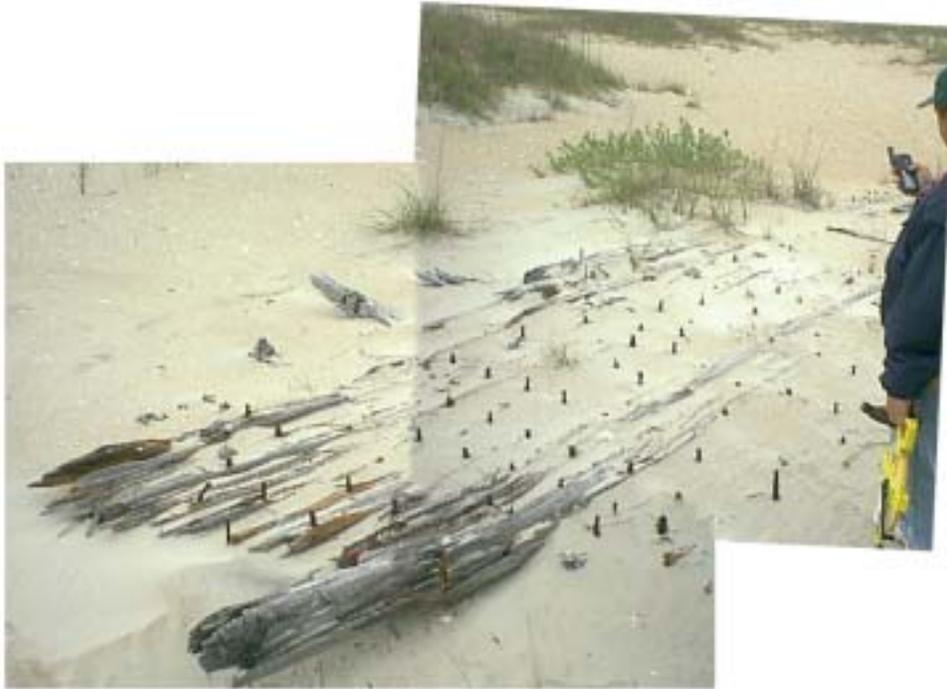
00, 413

This structure was very similar to **00, 170**, in appearance and in the fact that it represented more lateral bulkheads rather than lower structure such as keelson or framing.

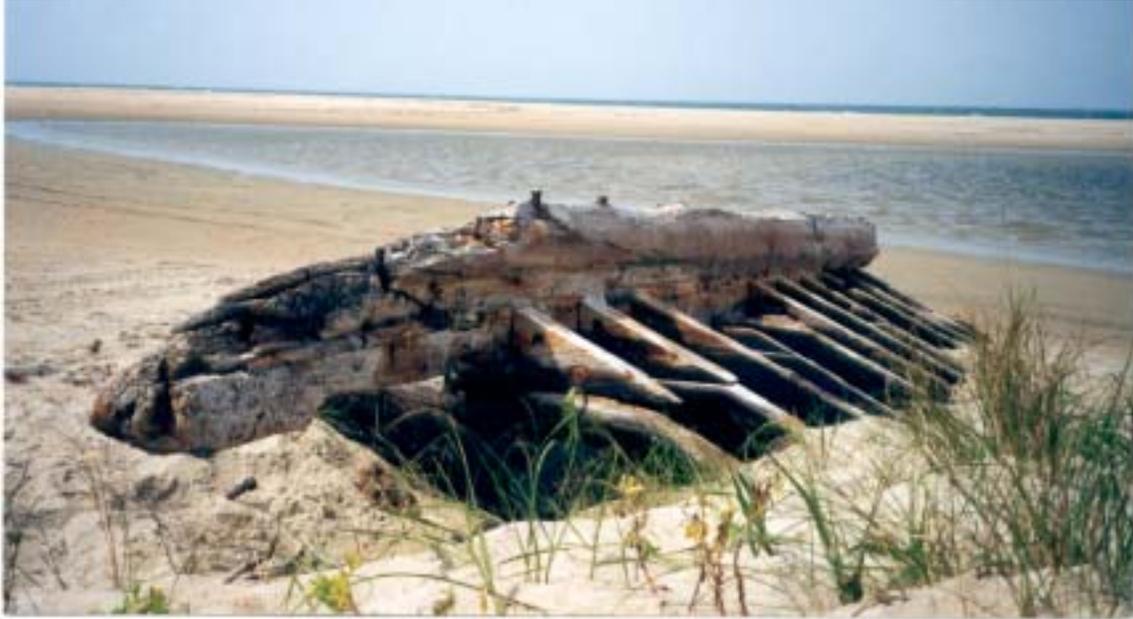
00, 414

The structure we tagged as **00,414** is lying upside down, fully exposed at **N 34 35'.519 W 76 32'.187**. Its fasteners were iron spikes and threaded bolts with nuts. The section measured 19' 4"X 5'X 2' 4". The structure appeared to be bow section, with associated framing timbers and a short keel with little or no keelson. The fastener patterns on the keel were "3 and 2, 3 and 2" and with the use of threaded bolt fasteners, it is possible that this is a more modern piece rather than an earlier wreck.

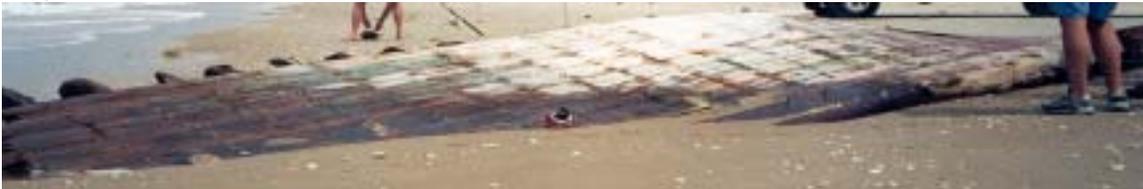
00, 415

We believe that this may be structure associated with the ill-fated fishing vessel *Josephine*. There is a huge amount of modern equipment present on the structure in the form of modern fittings including a sonar or “fish finder” transducer of some type and modern fasteners and materials. A brass strainer is also mounted on the bottom for engine cooling, thus suggesting a motor vessel. The structure appears to be from the starboard bow and also shows multiple coats of modern anti-fouling paint.

There is also one other piece of evidence that may suggest the fate of the vessel. There is a hole burned into the side of the vessel near the upper bulkheads that has penetrated to the outside of the ship. It is probably not from vandals as the piece looks to have been in place for some time and is awash at high tide. We believe that the *Josephine* may have been a casualty of a fire on board.

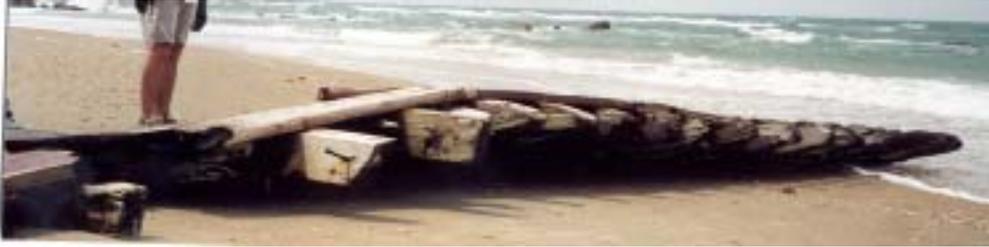
A closer look at the burned section (left side of photo) of the debris we believe may have come from the fishing vessel *Josephine*.

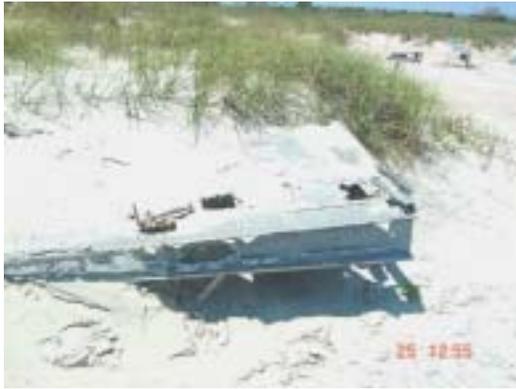
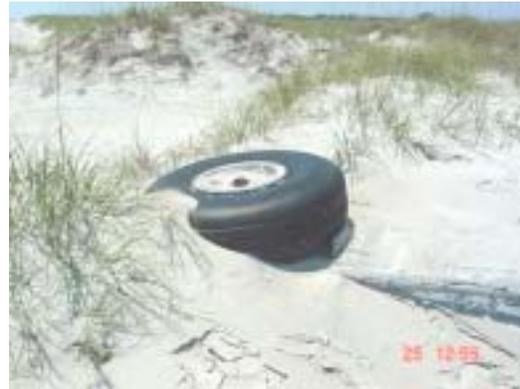
Aircraft Debris

The first structure we found on the North Core Banks survey was a concentration of assorted aluminum aircraft parts, most probably from a C-130 aircraft.

The items had been dragged into a pile and included a tire with magnesium rim, wheel brakes assembly and landing gear, cargo bay ramp door and associated rigging, and miscellaneous aluminum panels and scrap. Our best guess was that it came from an artificial reef or fell off of a decommissioned or scrap airplane during the building of an artificial reef. No hazardous chemicals were seen. The debris lies at **N 34 53'.500 W 076 15'.890**.

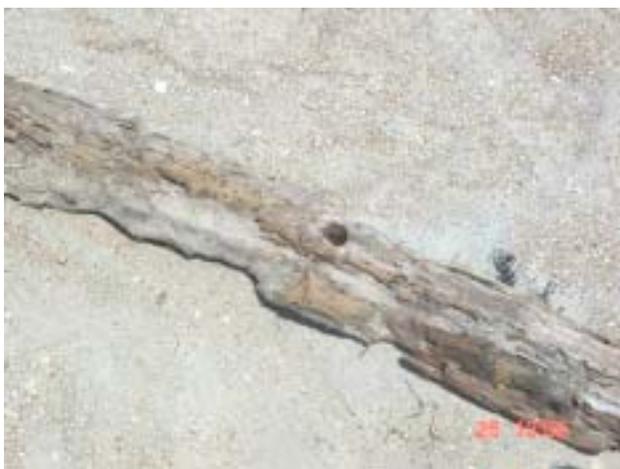
00, 416

A single deteriorated timber was located at **N 34 56'.152 W 076 12'.560**. This structure was lying in the middle of an active beach buggy route and was daily subjected to repeatedly being run over by trucks and large vehicles. There were 6 fastener holes, but no fasteners were present. The piece was 10' X 10" X 6" and was photographed and tagged with DCR tag no. 00, 416.

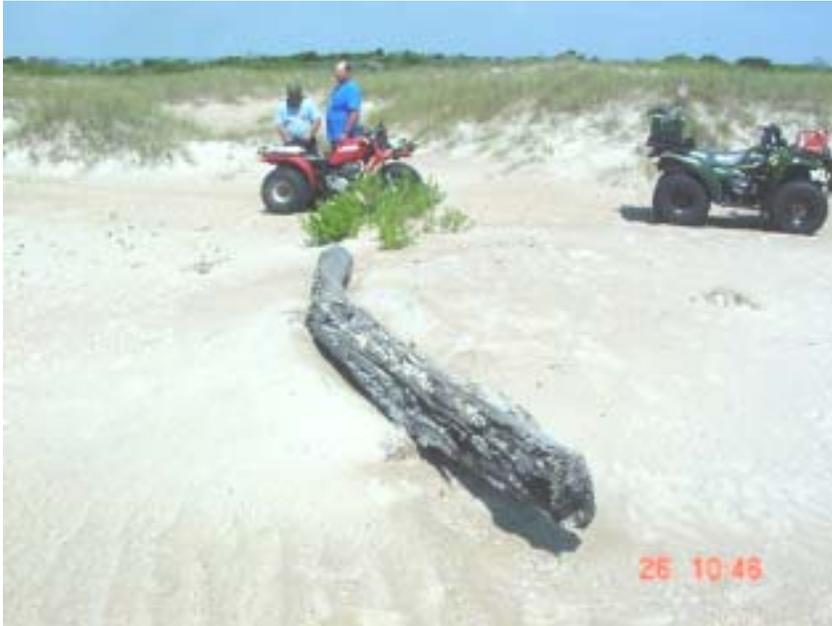
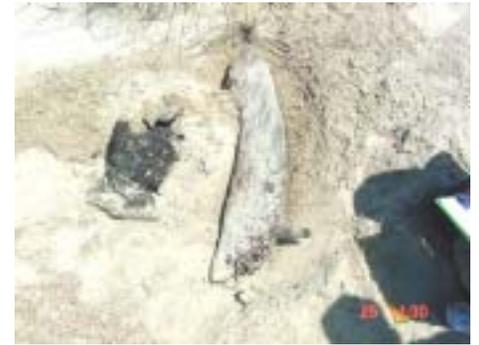
00, 417

The next set of structure we found was located at **N 34 58'.370 W076 09'.850**. These were two small pieces separated by about 100 feet, but were very similar in construction and were probably associated with one another. The smaller piece measured 3' X 8" X 6".

The smaller piece was hard to identify, but the larger piece was most probably a framing timber. The smaller piece could have been a "knee" or may have been broken away from a larger section. The only fasteners noted were wood "tren'les" and the fastener patterns were in a straight line of 2 or more per foot. The larger piece of structure was tagged.

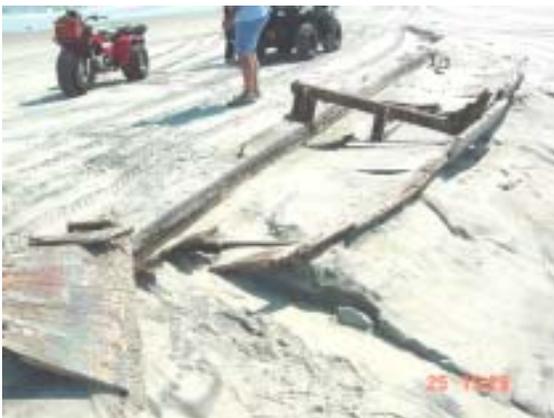
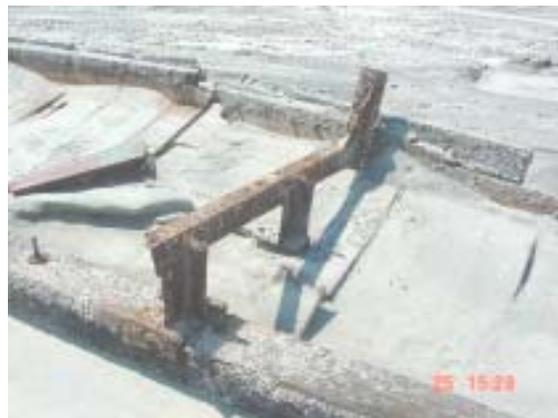
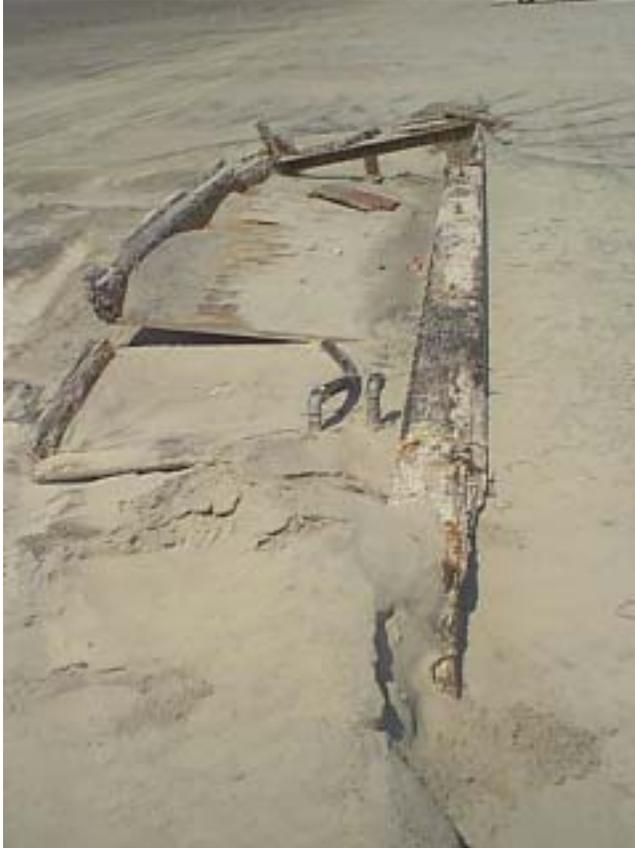
00, 418

This was most certainly the remains of a modern vessel, most probably a local fishing boat. The site is located at **N 35 03'.130 W 076 02'.67**. Theoretically it is possible that these could be further remains of the fishing vessel *Josephine*,

but a closer evaluation would be needed to verify the origin of the structure. The debris measured 35' X 6'3". All fasteners and hardware are modern and the vessel was equipped with iron motor mounts and a "keel cooler", a device mounted along the keel of modern boats to act as a radiator, using sea water to cool the engine's coolant as it flows by the keel. This was the port side, lower hull and the forward keel/ keelson. The outer hull was covered by multiple coats of anti-fouling paint. The structure was tagged.

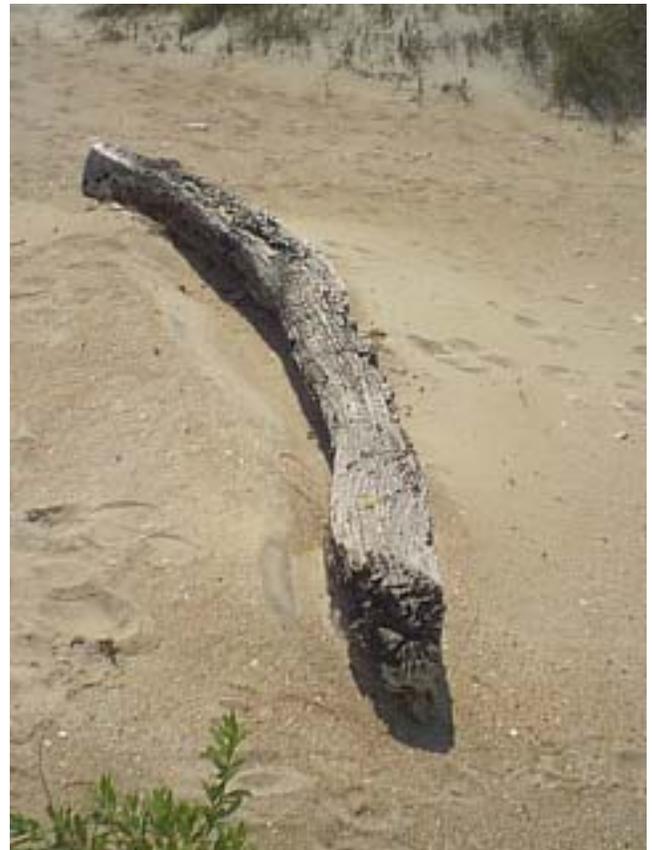
00, 419

This single "footuck" timber was located at **N 34 56'.780 W 076 11'.830**. The fasteners are extremely sporadic and seem to have a very complex pattern. All fasteners appeared to be wooden. The piece measured 16' X 10" X 7" The structure was tagged.
