The 2002 Core Banks Beach Wreck Survey

A Field Survey Conducted By SIDCO In Support Of The NCUAB Beach Wreck Program.

Beach Wrecks South (Cape Lookout to Drum Inlet)

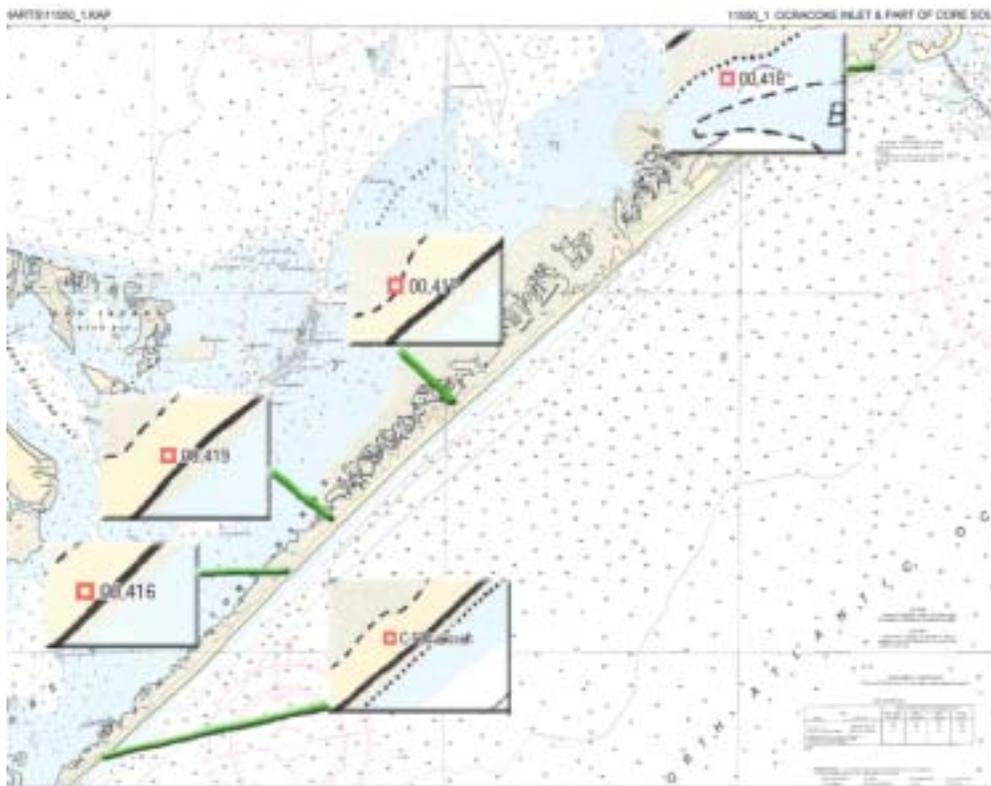
The North Core Banks Targets

The first structure we found on the North Core Banks survey was a concentration of assorted aluminum aircraft parts, most probably from a C-130 aircraft.

The items had been dragged into a pile and included a tire with magnesium rim, wheel brakes assembly and landing gear, cargo bay ramp door and associated rigging, and miscellaneous aluminum panels and scrap. Our best guess was that it came from an artificial reef or fell off of a decommissioned or scrap airplane during the building of an artificial reef. No hazardous chemicals were seen. The debris lies at **N 34 53'.500 W 076 15'.890**.
